**RAMADI 132-KILOVOLT SUBSTATION
RAMADI, IRAQ**

**SIGIR PA-08-153
JANUARY 27, 2009**

Ramadi 132-Kilovolt Substation

SUBJECT: Report on Ramadi 132-Kilovolt Substation in Ramadi, Iraq
(SIGIR Report Number PA-08-153)

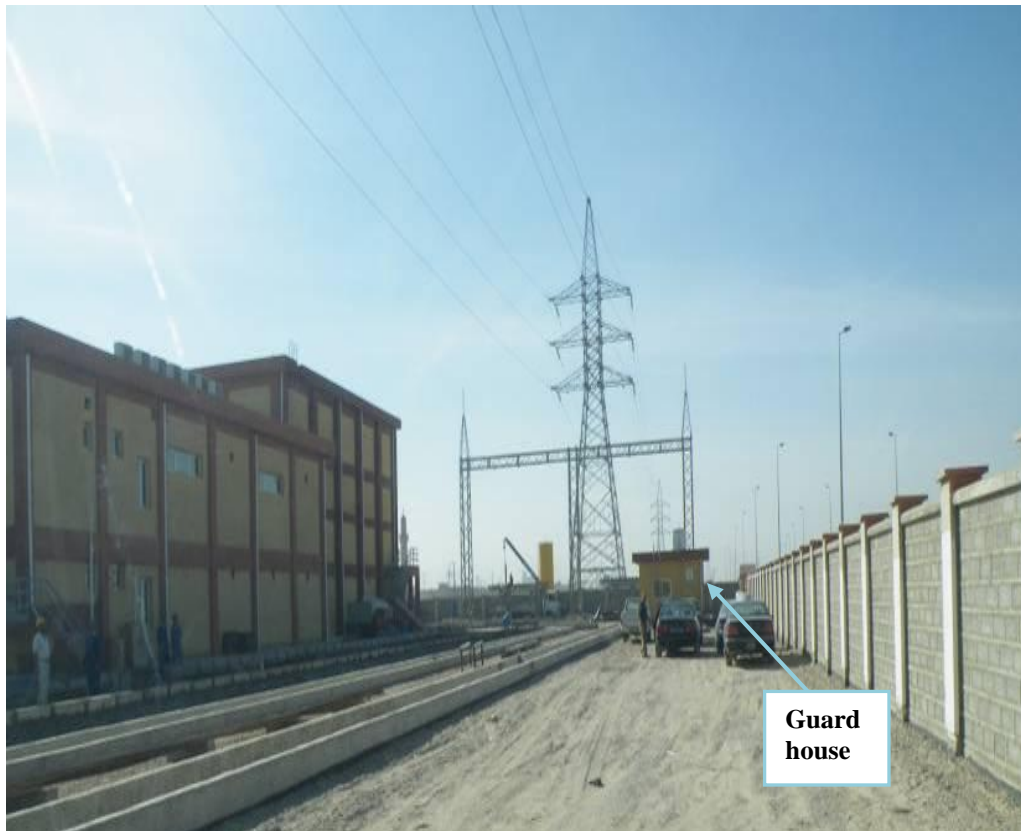
Site Photo 1. Guard house

The design required a guardhouse at the site entrance gate from the main public road (Figure 2). The site assessment team walked around the guardhouse (Site Photo 1); however, due to time limitations, did not enter. The wall design required a 2.0 meter high wall along the perimeter of the Ramadi 132-kV Substation (Site Photo 2), using thick reinforced concrete block (Site Photo 3) with a continuous reinforced concrete footer. The perimeter wall, surrounding the Ramadi 132-kV Substation, appeared well constructed with adequate brick alignment and quality mortar.

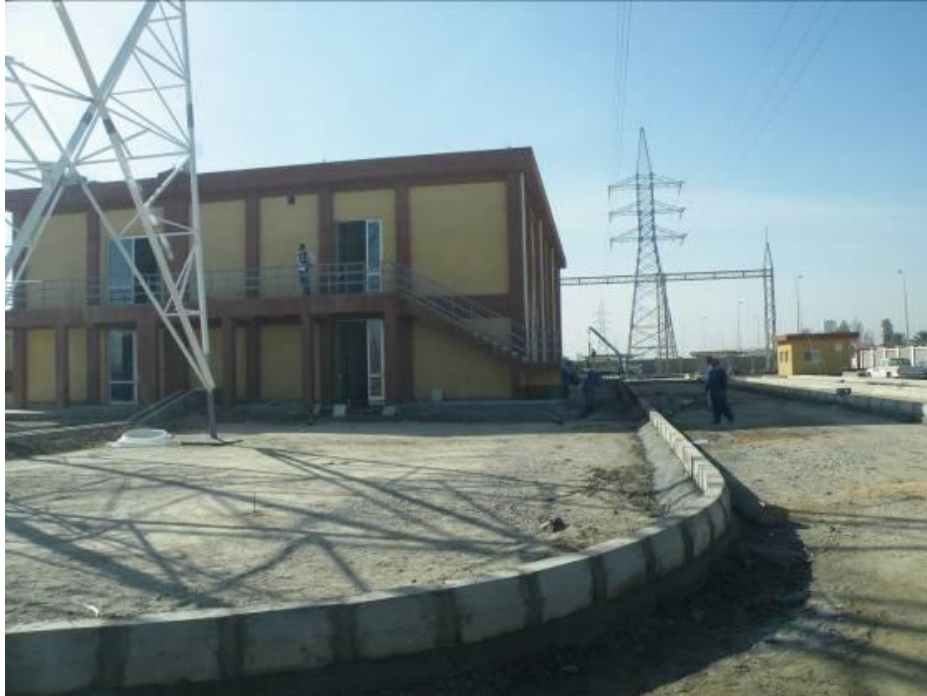
Site Photo 4. Exterior substation building

The design required that the substation building consist of a ground floor and a first floor. The building was to have through-wall ducts and trenches on all four sides for the appropriate transformer and feeder cables. The exterior of the 132-kV Substation building appeared to be well constructed (Site Photo 4). There were exterior stairs located at either end of the building.

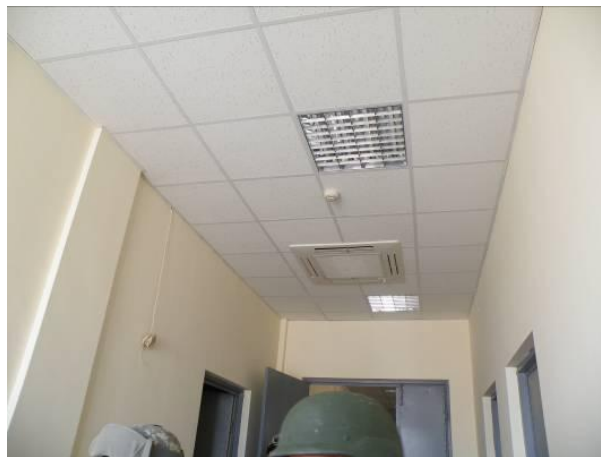
Site Photo 5. Interior finish

In addition, the interior of the substation building appeared to be well constructed (Site Photo 5). The ground floor design shows the columns required to support the heavy loads from the first floor's electrical equipment (Figure 3). During the site assessment, the inspectors observed that the ground floor columns were painted and there did not appear to be any patches. There were no obvious signs of cold joints, honeycombing, or steel exposure. The contractor had properly aligned and connected the elevated cable trays to the substation structure (Site Photo 6).

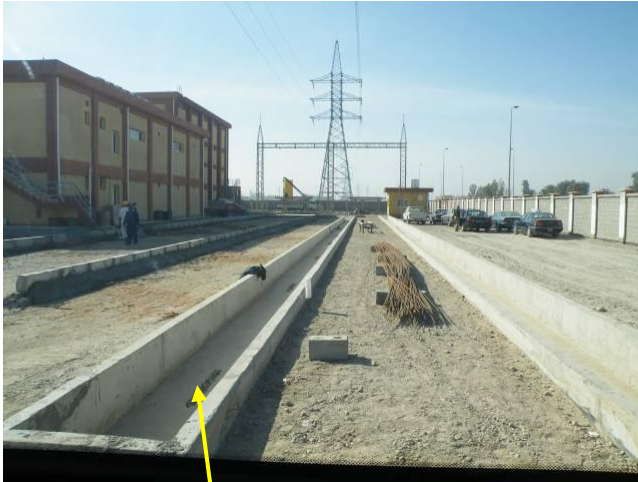
Site Photo 7. Cable trenches

The design required through-wall ducts and trenches for 132-kV feeder cables, 132/33/11 transformer cables, 33-kV feeder cables, and 11-kV feeder cables (Figure 4). The concrete cable trenches appeared to be well constructed and monolithic (Site Photo 7). For the wet season, the interior of the cable trenches has French drains (Site Photo 8). The cable trench proceeds up to the building (Site Photo 9), and the exterior wall of the substation has conduit installed to allow for the passage of cables from the transformer cables to enter the interior of the substation and for the feeder cables to exit the building (Site Photo 10).

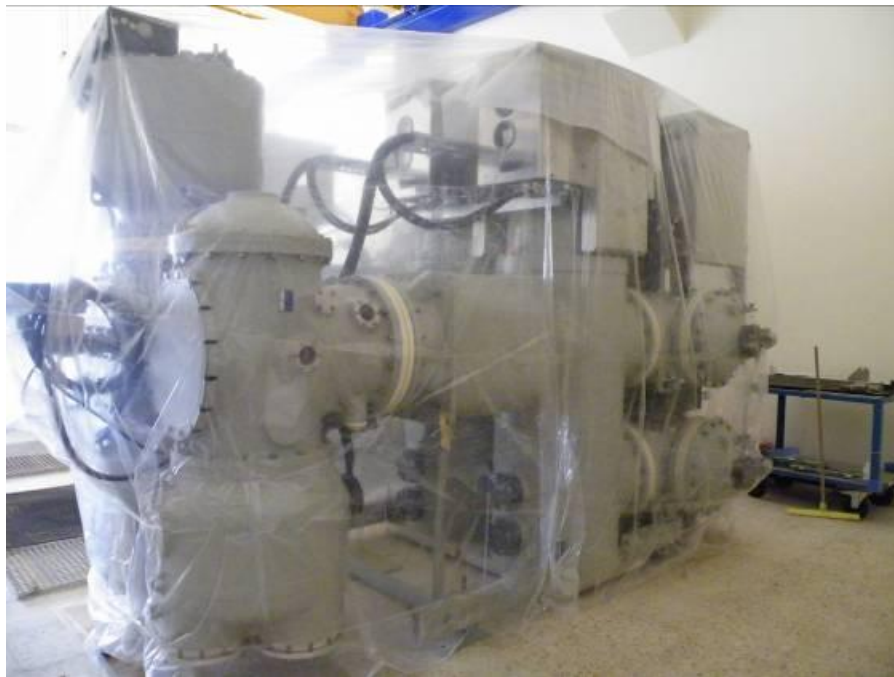
Site Photo 11. Gas insulated switch

The design required the first floor of the substation building to have five main areas. Main areas of the first floor include the 132-kV switchgear room, 33-kV switchgear room, control/relay room, communication and battery room, and 11-kV switchgear room (Figure 5). During the site assessment, a majority of the switching equipment was not completely installed, and the GIS was still in the original plastic wrapping (Site Photo 11). The site assessment team observed that the Gantry crane was installed, but not operational (Site Photo 12). The contractor stated that the electrical equipment required complete assembly before Site Acceptance testing could be performed. Until repaired or a work around solution is found, the damaged GIS units are preventing complete installation and testing.

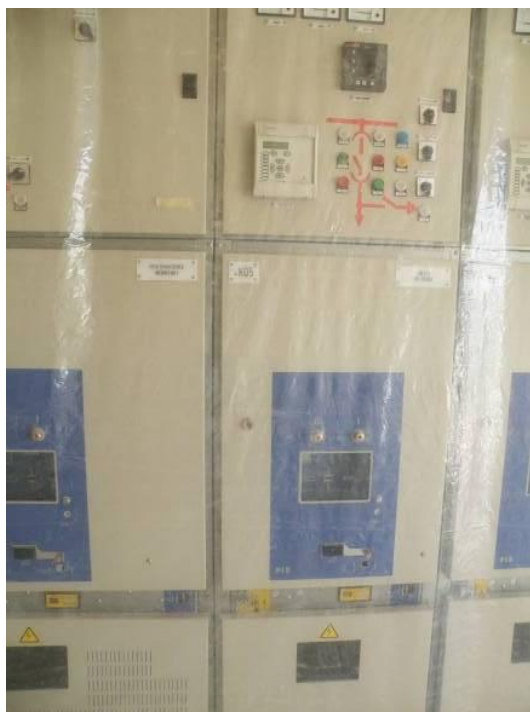
Site Photo 13. Electric metering equipment

The contract and design required the purchase of a 33-kV and 11-kV switchgear and installation of the switchgear into the newly constructed substation building. The site assessment verified the installation of the 33-kV and 11-kV bay of electric metering equipment (Site Photo 13). Details from the associated factory nameplate were not obtained during the site assessment; however, the equipment and installation appeared to be consistent with the contract, design, and specifications.

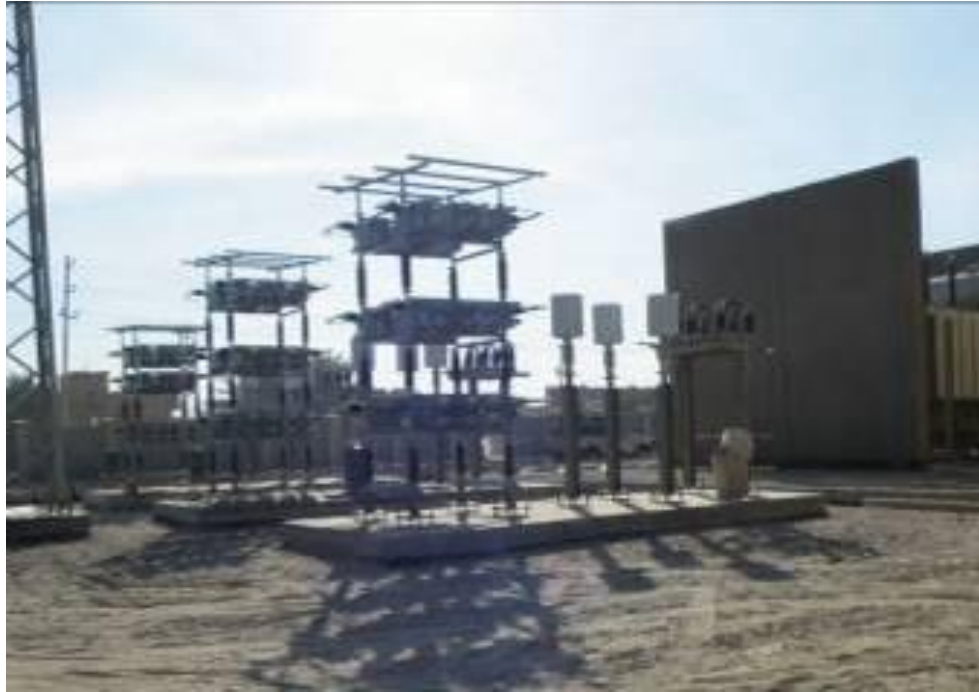
Site Photo 14. Capacitor banks

The capacitor banks looked new in appearance (Site Photo 14). The capacitors should provide greater reliability for the substation since the capacitors hold a charge on the system. This will provide a lag in the power drop when power is lost and will

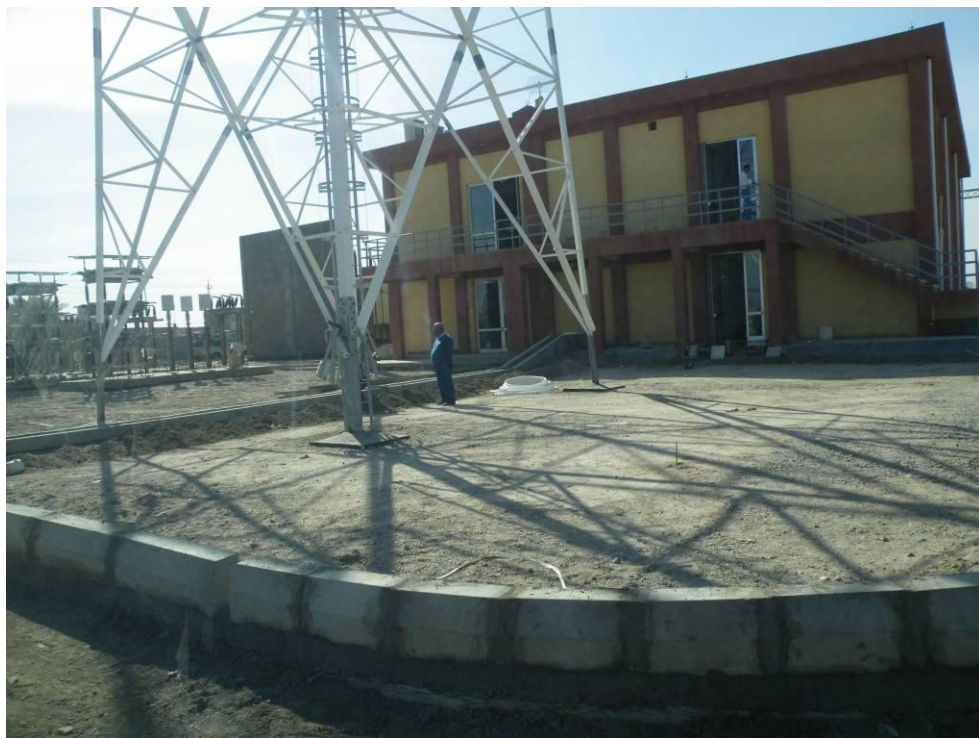
Site Photo 15. Communications tower

maintain power in the system until power is restored. SIGIR verified the installation of a communications tower (Site Photo 15).

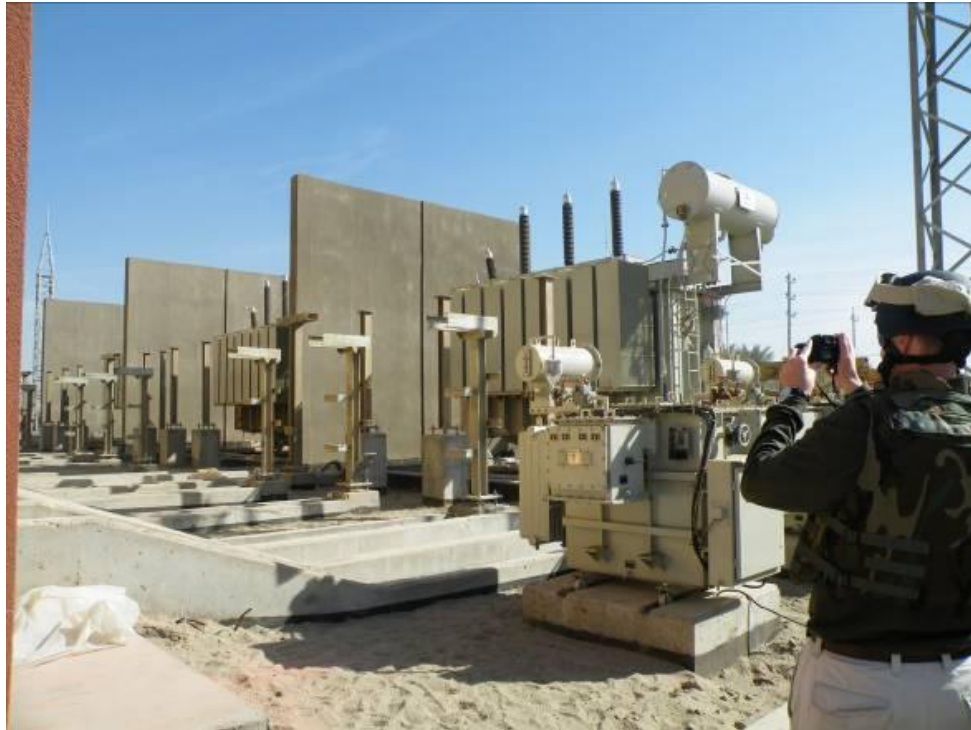
Site Photo 16. Transformer bays

The transformers, located behind the substation building, had a filter apparatus connected to filter the dielectric fluid. The USACE representative stated that the dielectric fluid should be free from any air or particulates. The transformer bays had gravel grid that was clean and well sorted; the gravel absorbs any oil that leaks from the transformers. In addition, large walls separate the transformers to contain the spread of a potential fire (Site Photo 16).

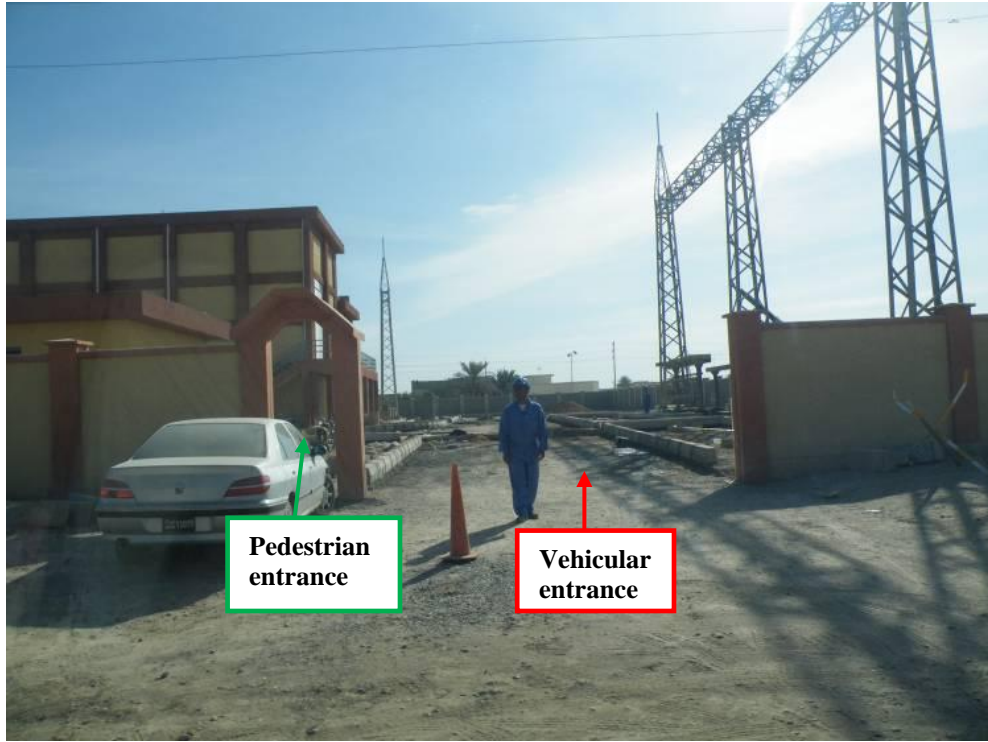
Site Photo 17. Pedestrian and vehicular entrances

Since the project was reportedly 88% complete, the substation is still under construction in various areas. The contract required the vehicular and pedestrian entrance gates to be made of steel construction. Currently the contractor has not completed the vehicular entrance or pedestrian gates (Site Photo 17). In addition, the contract stated that the contractor would provide external access roads. When the site assessment team toured the Ramadi 132-kV Substation, the roads were still a work in progress (Site Photo 18).

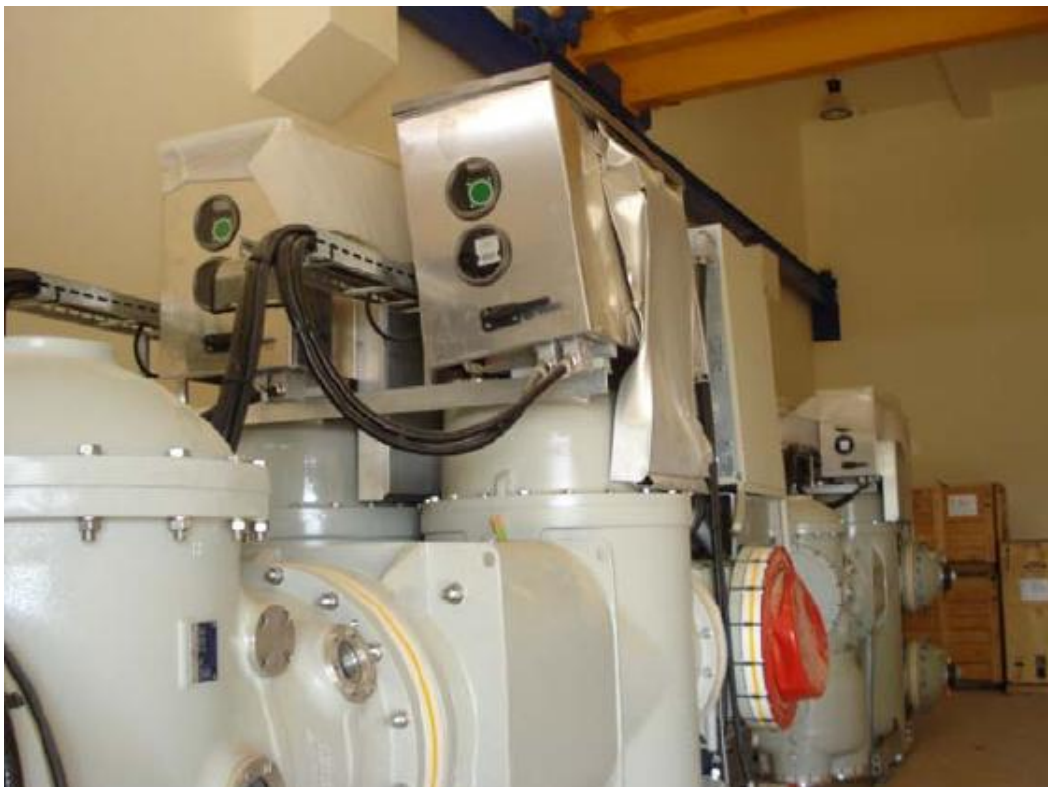
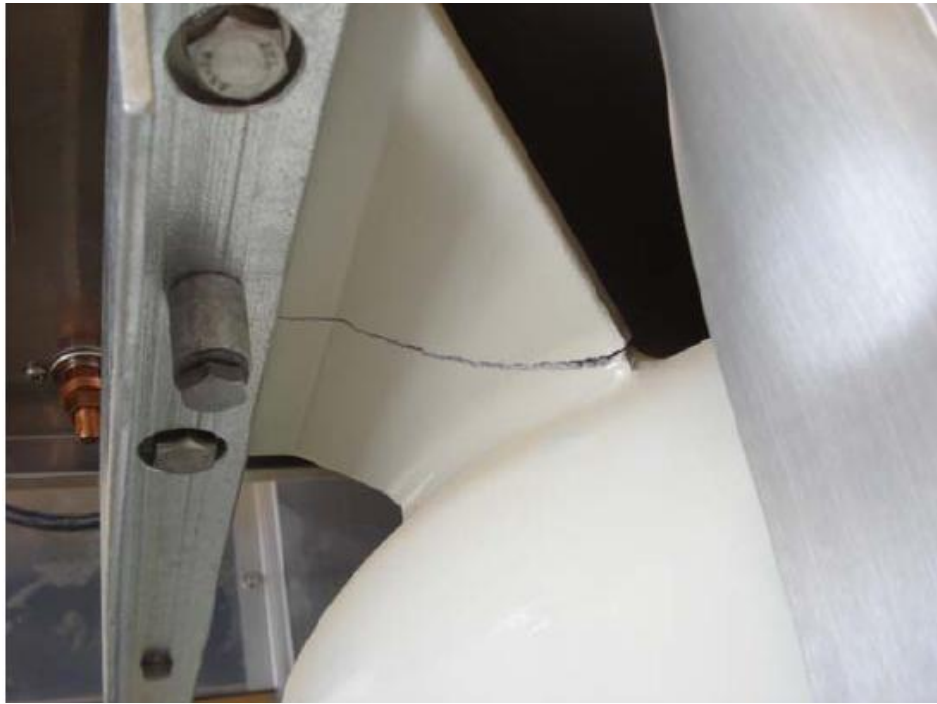
According to USACE, during the installation of the electrical equipment, the contractor noticed that one GIS had a crack in the housing that rendered the equipment unusable. The damaged 132-kV GIS bays E05 and E06 (Site Photo 19) have broken mountings, which are for the circuit breaker operating mechanism boxes, and damaged flanges for the busbar compartments. The mountings, located on the top of the circuit breaker head cover, cannot be repaired on site (Site Photo 20). A visual inspection of the damaged 132-kV GIS mountings indicates that professional welding is required. If welded in the field, the application of heat could damage the GIS. In addition, the impact that caused the break could have damaged internal GIS components. A factory examination can verify whether the internal moving parts were disturbed. Until the E05 and E06 are repaired and installed, one transformer (E05) and one line bay (E06) will not be commissioned.

On 30 November 2008, the USACE received an email from Areva, the vendor, that stated that the GIS casings were not opened. Areva's worst-case scenario was that rebuilding the units would take approximately twelve months. If the vendors have the critical parts available, then the time can be reduced. USACE indicated that different options were being discussed to circumvent waiting for the estimated period for returning the GIS equipment. USACE may take advantage of the design redundancies in the system and run the substation with the other GIS. However, USACE indicated that if this is done, the commissioning of the system would need to be reviewed and the warranty time with Areva may be increased.

Site Photo 19. GIS E05 and E06 (Courtesy of USACE)

Site Photo 20. Cracked GIS E05 and E06 (Courtesy of USACE)

In addition, the contractor should inspect and verify items as soon as received on site. According to USACE, during the installation of the electric equipment, the contractor noticed that one GIS had a crack in the housing that rendered the equipment unusable. Through a visual inspection of the 132-kV GIS, the contractor could have identified the problem earlier in the project.

1. Continue efforts to expedite repair of the gas-insulated switchgear.
2. Require the contractor to provide the 90% design submittals.

Command Comment. Concur. The switch manufacturer will replace the gas-insulated switchgear units. The contractor is expeditiously working to obtain replacements for the three defective GIS units from the manufacturer.
